RUSH RESERVOIR  
MONROE COUNTY  
NEW YORK

INVENTORY No. NY 1341

PHASE I INSPECTION REPORT  
NATIONAL DAM SAFETY PROGRAM

MAY 1981

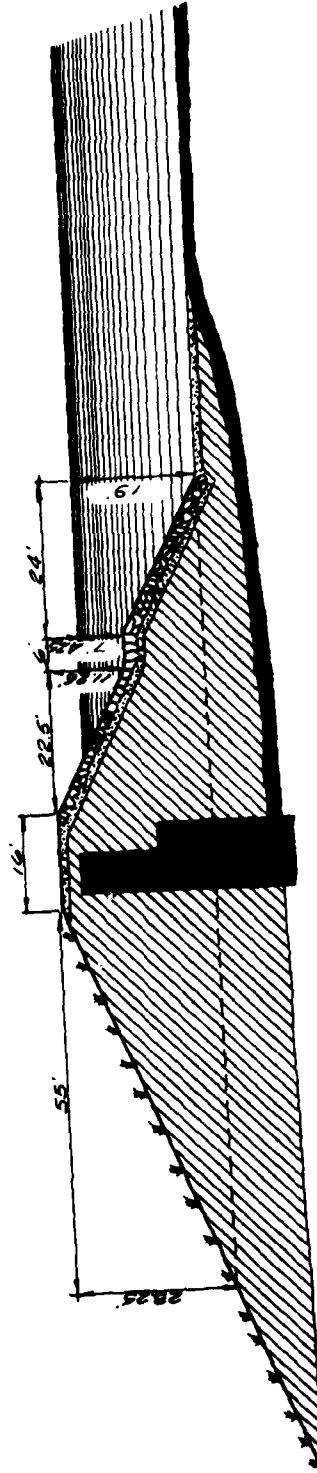
FIGURE 3

No information regarding the structural stability of the structure was located. Drawings included in Appendix F substantially conform to the present facility. The drawings indicate the interior slopes of the earthen embankment to be 2:1 (2 horizontal to 1 vertical) with a 5 feet wide bench at about mid-height to produce an effective slope of about 2.2:1. Riprap is shown lining the interior slopes all the way to the reservoir bottom. The exterior slopes scale to be about 2.5:1 which conforms to field observations. Bureau of Water personnel believe that there is a clay core in the embankment and a clay blanket lining the reservoir bottom. This is supported by drawing K-14 (Figure No. 3) which suggests the presence of a core and a blanket lining tying into this core.

The only documented changes in the reservoir system deal with the pipe network. However, drawing K-14 (Figure No. 3) shows the "Original Front Angle" to be about 5 feet inside of the existing interior edge of the crest. This could be due to the embankment crest being raised or the addition of the interior slope bench in the design before construction commenced.
